Ask Dr. Gel

Gelcoat Cracks and Delaminating

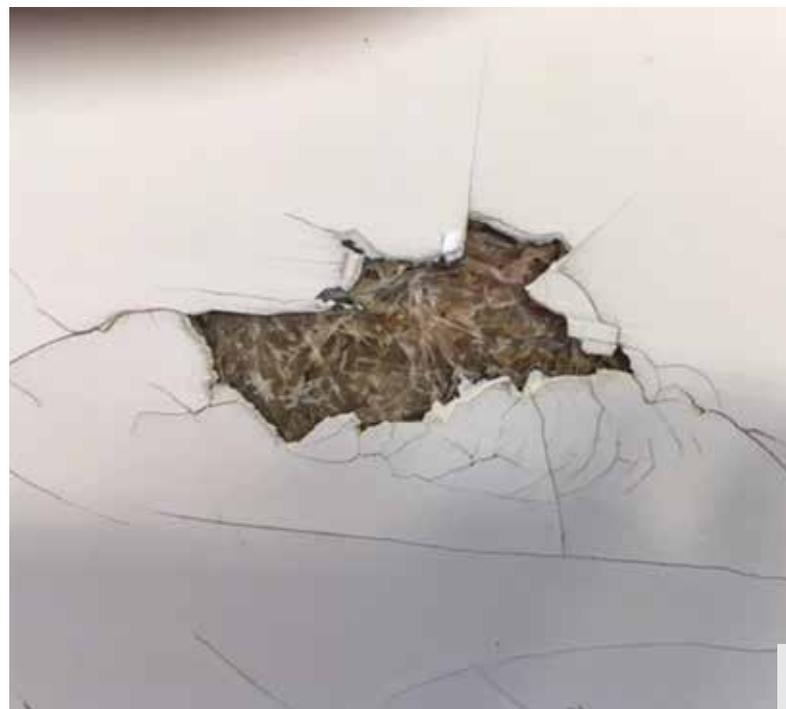
Loose Gelcoat falling off hull
Note excessive thick Gelcoat.

The problems shown in the photos of this boat are caused by excessive gelcoat. To my surprise the boat was built by a highly respectable and very experienced manufacturer. The gelcoat on the hull was actually falling off and the start of blisters were apparent. Normally blisters are evident first followed by cracks that connect the blisters. This allows water to go through the gelcoat speeding up water intrusion into the laminate.

The repair method in this situation required scraping off all the loose gelcoat first by hand. I used a putty knife with very little effort. I scraped until I found good adhesion. After the loose gelcoat was removed I examined the laminate. Good laminate has a deep purple color and shows healthy laminate. The areas that are white indicate bad laminate and I had to keep grinding until good is revealed. After the grinding was complete the area was layed up with epoxy resin and heavy biaxle fiberglass mat. It was then ground to shape and additional epoxy fiberglass fillers were applied. Next step was sanding and recreating original body lines. The areas were prepped for epoxy barrier, sanding with 80 grit and then the barrier was applied. Epoxy barrier was chosen to slow down any more potential water intrusion hoping to extend the life of the boat.

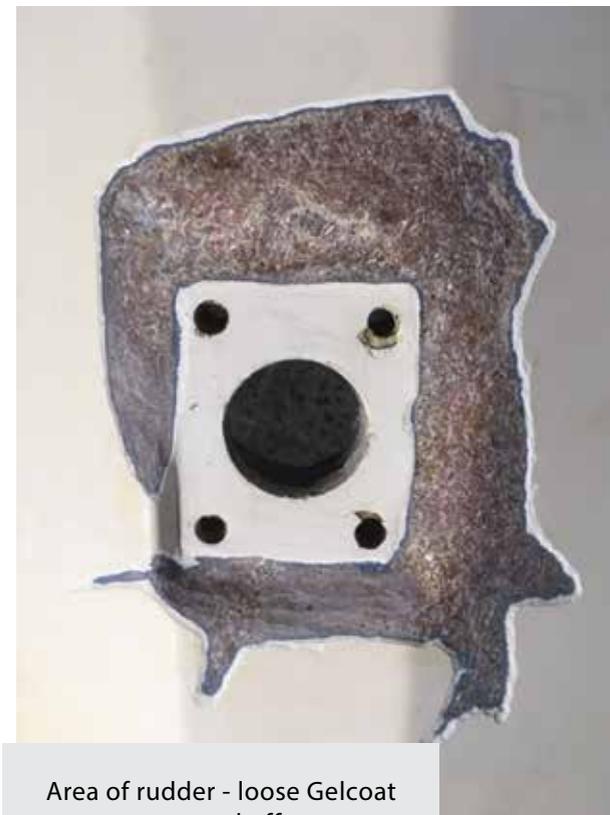
Area of rudder - loose Gelcoat ground off.

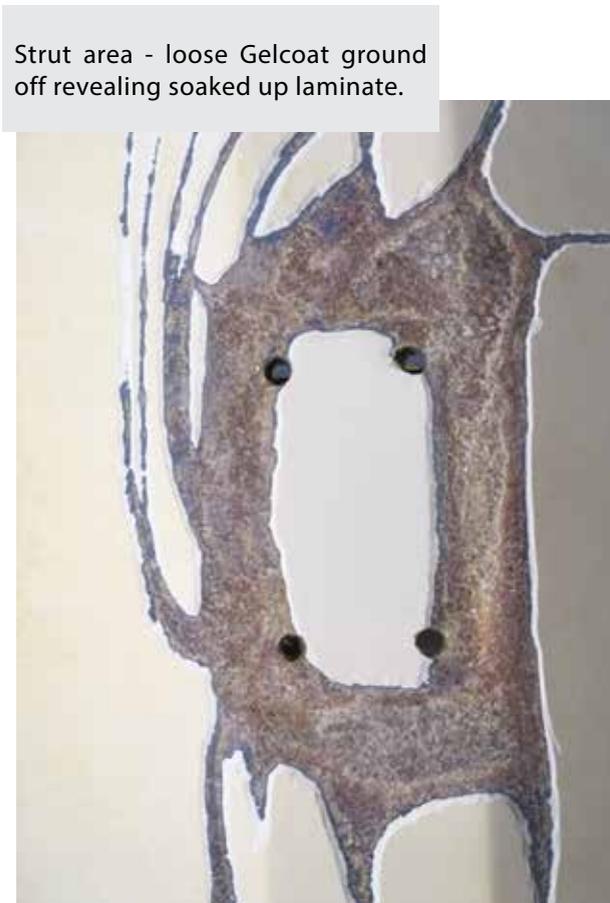
Strut area - loose Gelcoat ground off revealing soaked up laminate.

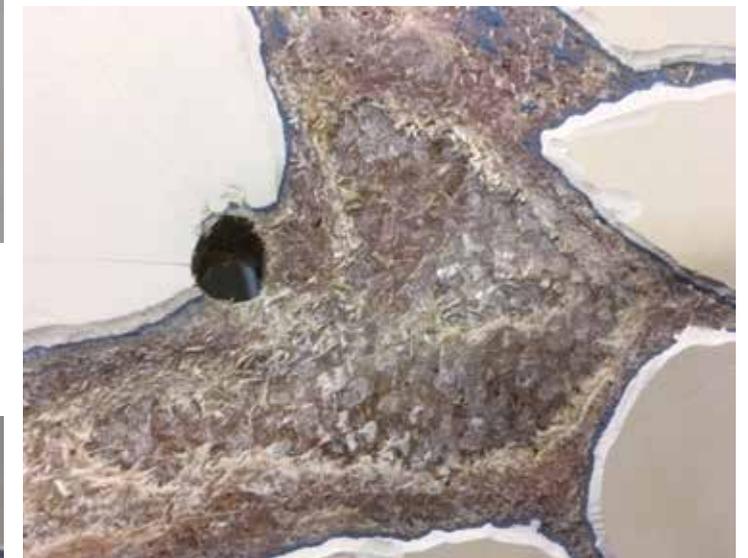
Close up. Strut area. White areas indicate bad laminate.

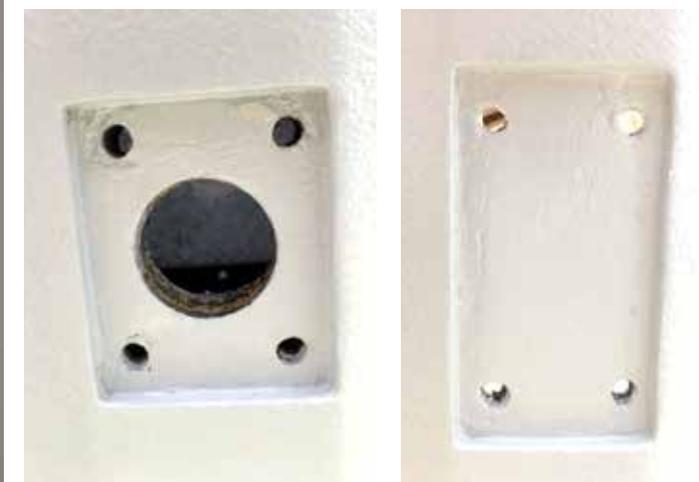
Rudder and strut area repair complete.

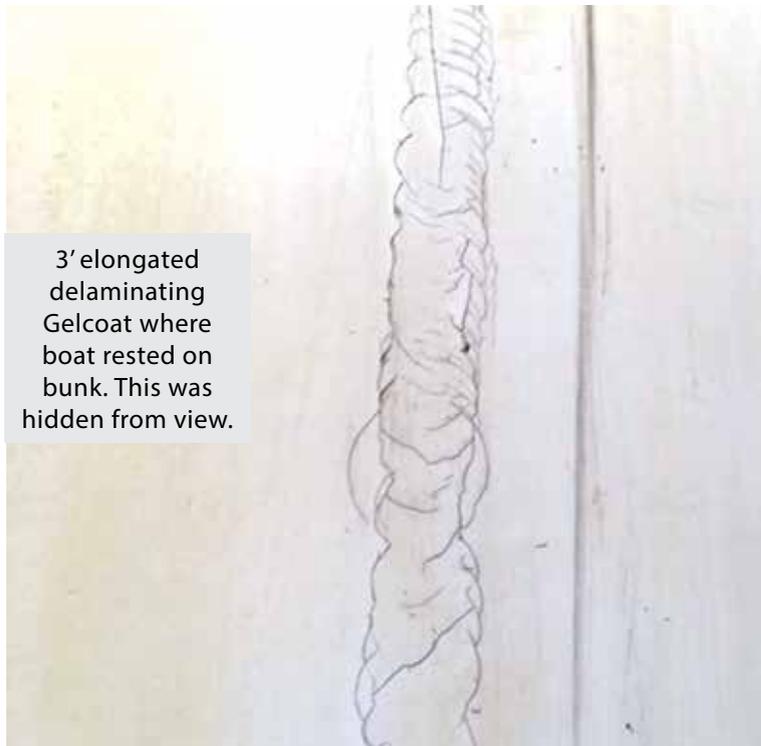
3' elongated delaminating Gelcoat where boat rested on bunk. This was hidden from view.

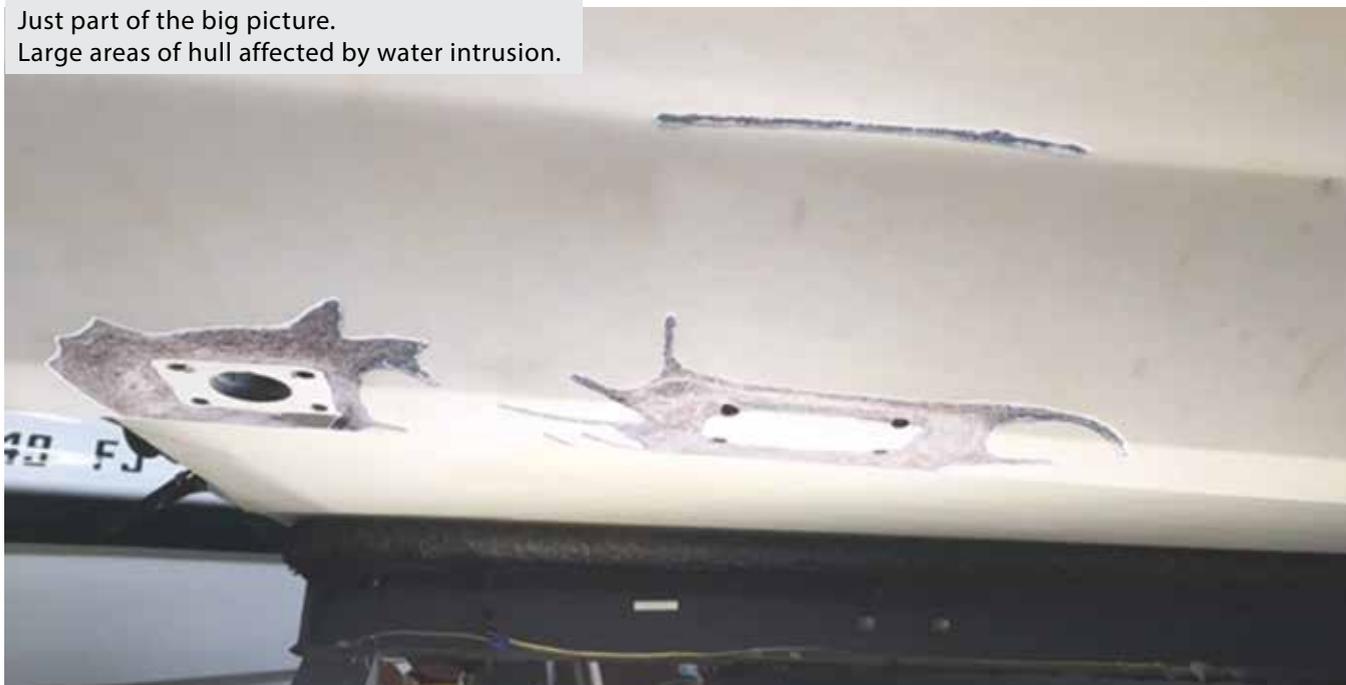
Just part of the big picture. Large areas of hull affected by water intrusion.
