Ask Dr. Gel

“What’s with all these cracks?!”

“Dr Gel, I have a large amount of serious cracks on the inside of my outboard motor boat in the spill well corners, what’s causing it and can they be repaired?” Tim

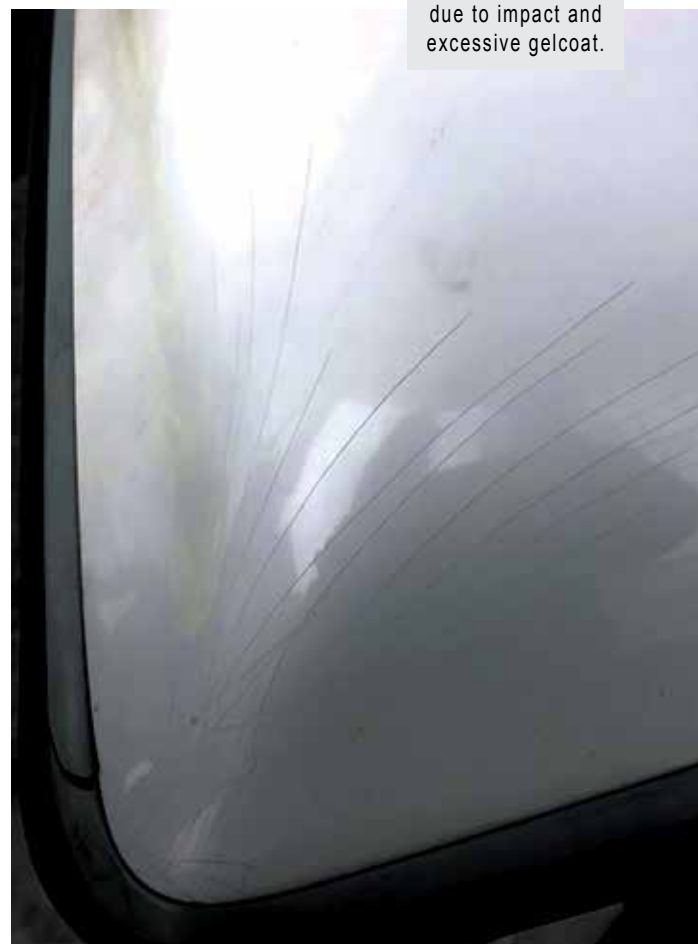
Cracks starting from under rub rail due to impact and excessive gelcoat.

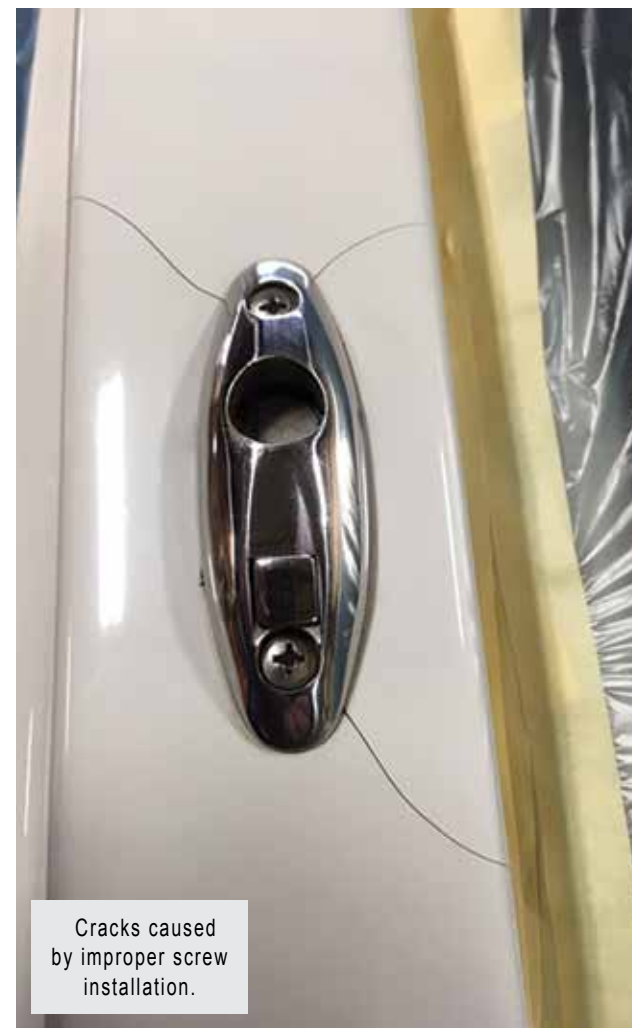
Cracks caused by improper screw installation.

One very common cause of cracking as mentioned is clearly seen in photo; not properly drilling for hardware, snaps and windshield screws. If a hole is not properly predrilled the fastener goes in and lifts the edge of the gelcoat resulting in the beginning of a crack that will travel like a crack in a windshield Here’s the proper way to drill for fasteners- First use a sharp drill. Put the drill in reverse and make the hole turning the drill backwards. The hole also needs to be chamfered so when the screw is put in the hole the threads do not pick up on the edge of the gelcoat. Bass boats with high powered motors, jack plates and high speed running over rough waters will cause cracks in the spill well. It’s the nature of the beast. The manufacturer could not make it strong enough to

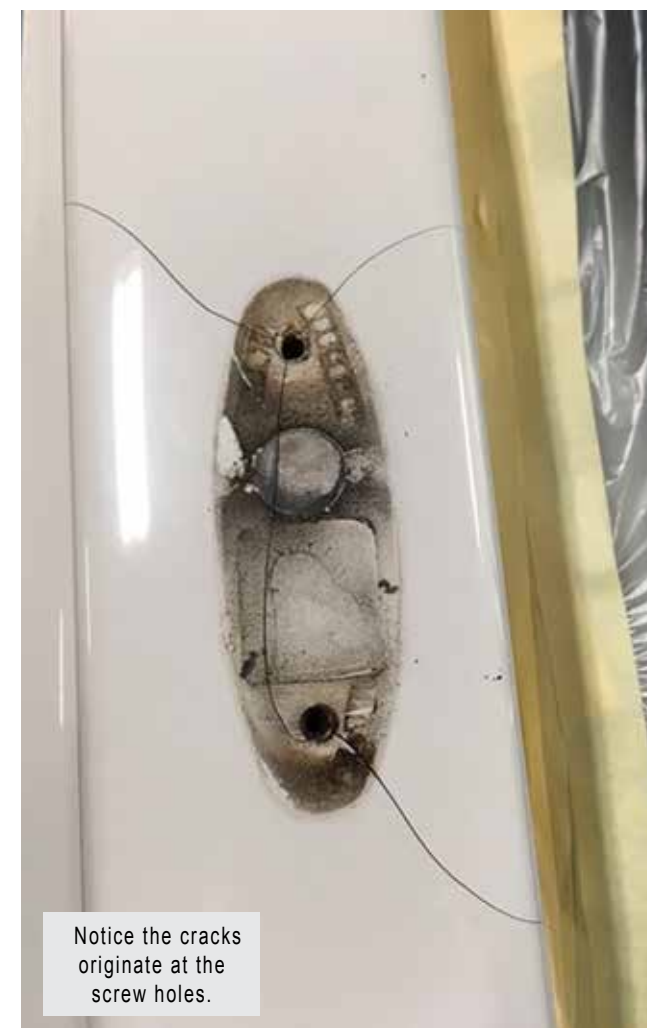
Notice the cracks originate at the screw holes.

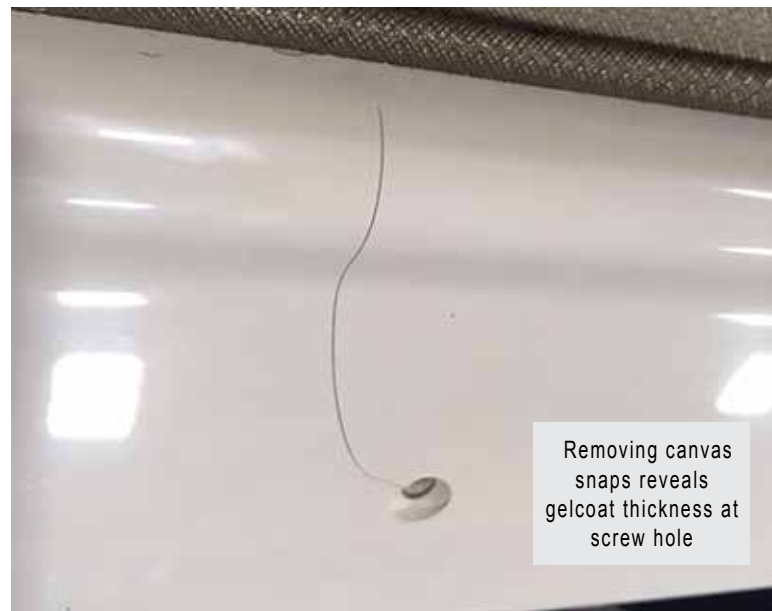
prevent cracking. It's usually cosmetic and not structural. Everything else is flexing just not the gelcoat. And once again the thicker the gelcoat the more susceptible to cracks. Here's a suggestion if you are looking to buy a boat. Ask to have a small piece of hardware removed in an area that will clearly show the thickness of the gelcoat.

Removing canvas snaps reveals gelcoat thickness at screw hole

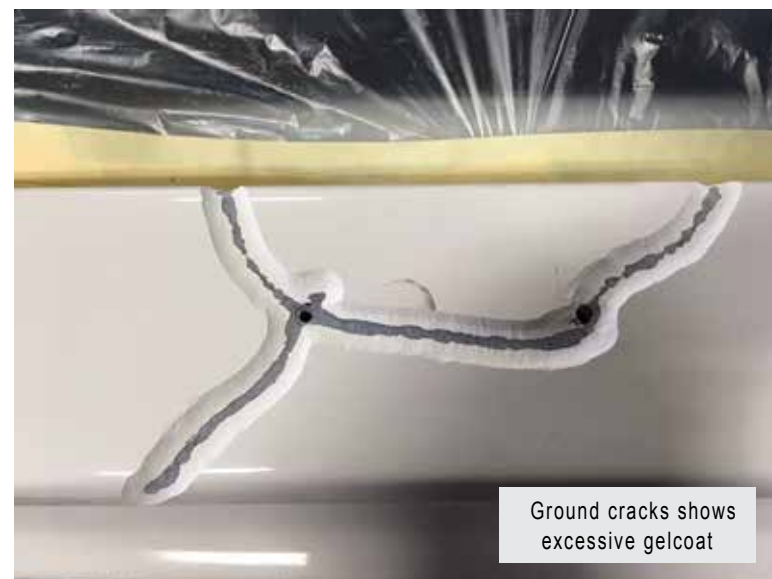
In your situation Tim, excessive gelcoat applied to the mold during production of your boat is the cause of the cracks. The gelcoat should be routinely measured to specific mil thickness using a wet film thickness gauge. The preferred thickness should be between 18-22 mil. I have seen gelcoat as thick as 3/8 during a repair process and brand new boats with multiple cracking due to excessive

Ground cracks shows excessive gelcoat

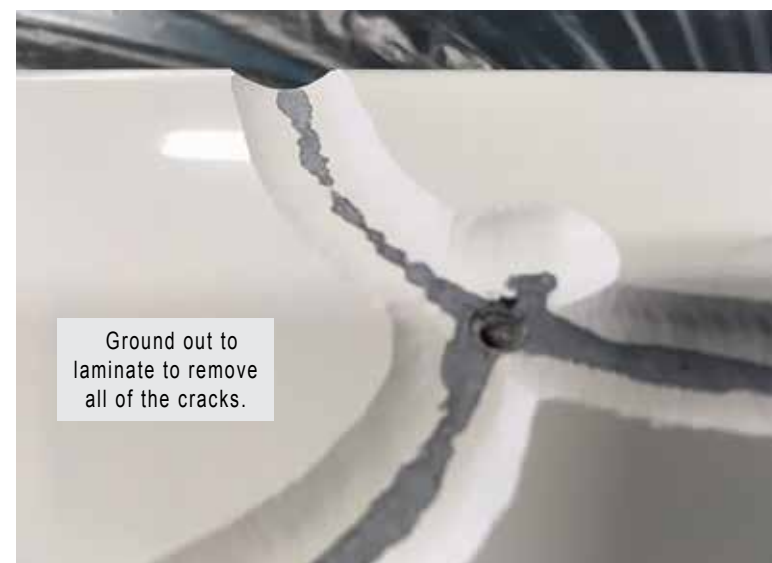
Ground out to laminate to remove all of the cracks.
