# Ask Dr. Gel

## “On The Rocks” ... not the kind I had in mind.

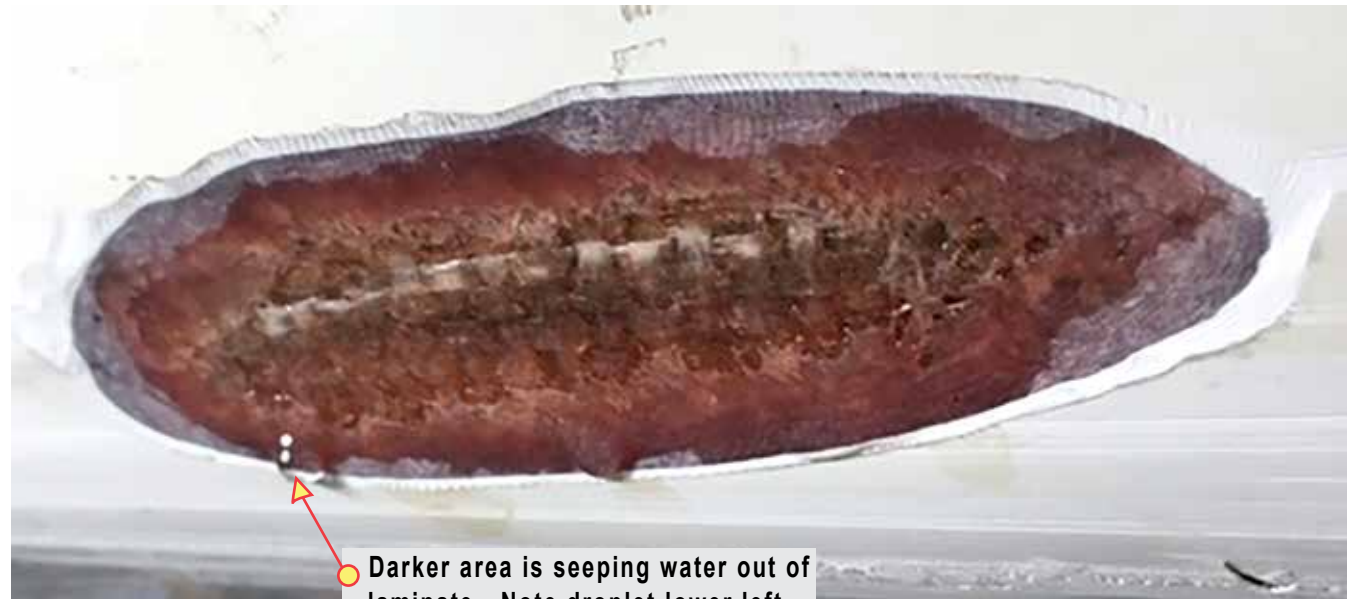
Darker area is seeping water out of laminate - Note droplet lower left.

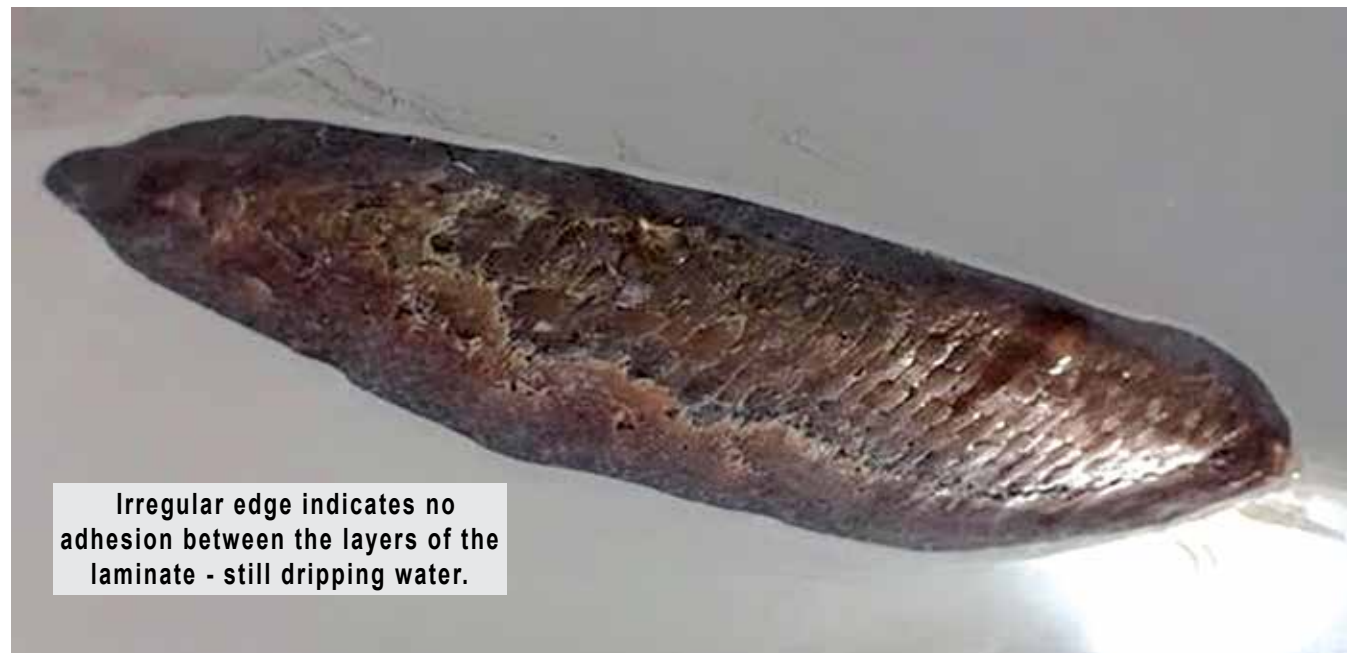
created by leaving it in the water. In addition, as I inspected the hull further I discovered that the laminate separations were manufacturing issues. Delaminating caused by poor manufacturing and I have written articles about it. I have seen this occur in other boats during my many years of experience repairing boats. This manufacturing defect is adding more troubles for this owner!

It had a real crappy lay up! It looked like at the techs at the manufacturing plant sprayed the fiberglass chop mixed with resin and waited too long to add subsequent layup layers. Did they decide to go to lunch... The last layer they sprayed in acquired a blush and the subsequent layer added “after lunch” didn’t adhere. As a result no adhesion but they kept laying up the hull.

Irregular edge indicates no adhesion between the layers of the laminate - still dripping water.

I ground out the damage, and laid it up properly with multiple layers of epoxy resin and mat, ground and sanded it. When that step was completed I prepped and applied epoxy barrier to finish. The layup on this boat was done poorly. It became known due to

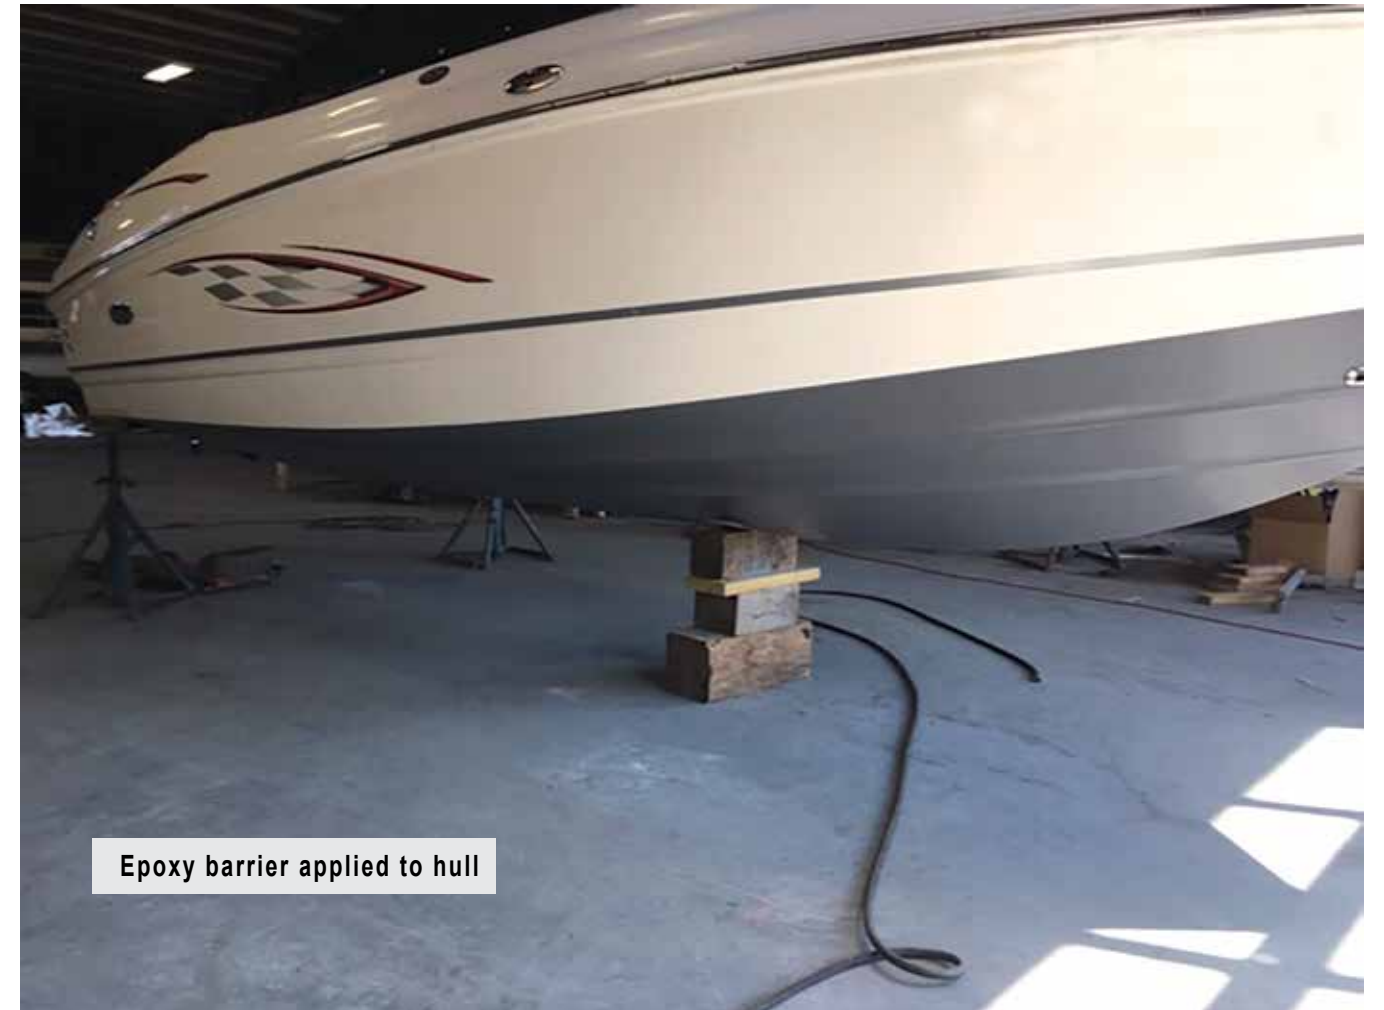
Epoxy barrier applied to hull
