Ask

Dr. Gel

by Dave Weakley

Winter's freeze takes a toll on a Mastercraft leading to a resurrection

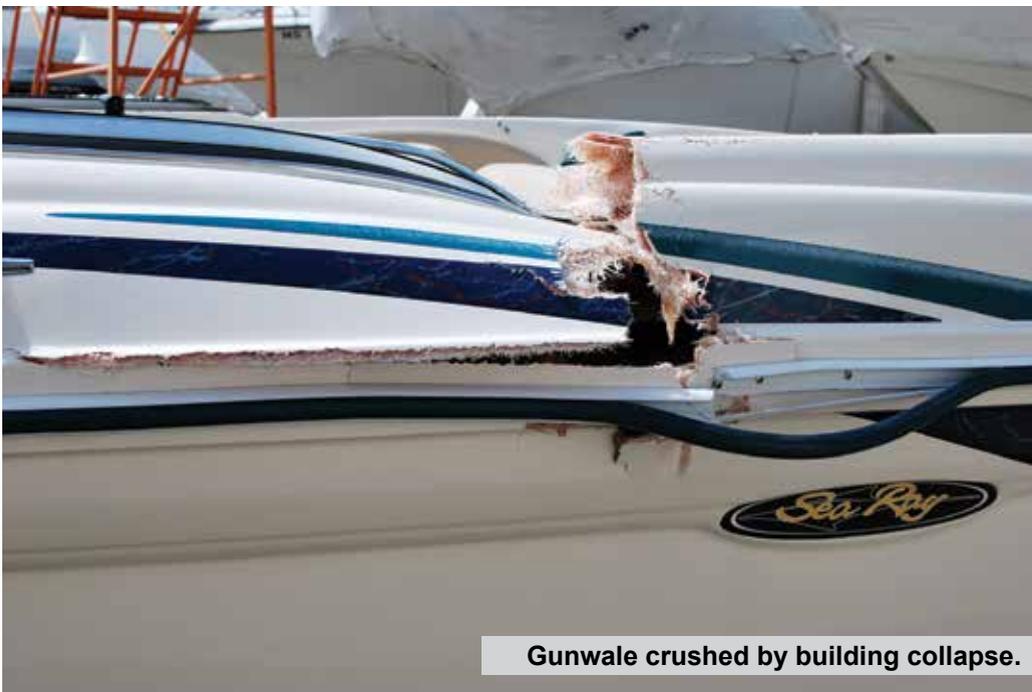
Gunwale crushed by building collapse.

Is the boat stored in a "wanna be" make shift garage, barn, under old tress with big limbs, or under anywhere where snow and ice load can accumulate? Is the building sturdy? Roof/limb collapse can cause catastrophic boat damage. We have have repaired a lot of crushed gunwales, windshields, etc.

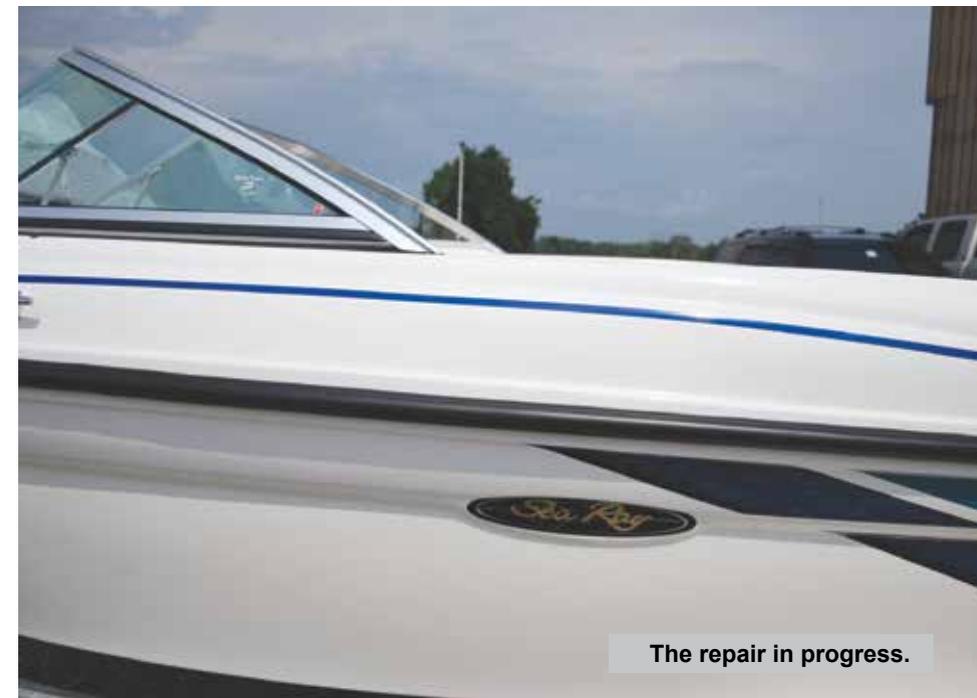
During a harsh and cold winter a few years ago a 1997 Mastercraft Prostar 205 LTI boat was stored outside. In the early spring the owner discovered the wake board tower on it was damaged. The tower was designed to slide down into a pipe. The pipe filled with water and froze causing the tower to crack. The old tower needed to be removed and a new one replaced. Due to the age of the boat the original tower was no longer available and the old tower mounts would not line up with the new ones. The old holes had to be properly repaired and new holes drilled.

The repair in progress.

In order to do the repair all the paint on the deck needed to be removed. The rub rail and insert had to be removed along with all the hardware including bow railings, stern grab handles and canvas snaps. I used Peel Away® Marine Safety Strip Paint Remover to strip the

After all the paint was removed the old tower holes were repaired with Mas epoxy resin and fiberglass materials for strong reinforcement. The numerous gashes and scratches that were revealed were ground out, filled with fiberglass fillers and sanded. The deck was sanded and prepped for new Oyster white gelcoat. After applying the gelcoat it was sanded, compounded sealer glazed and waxed.

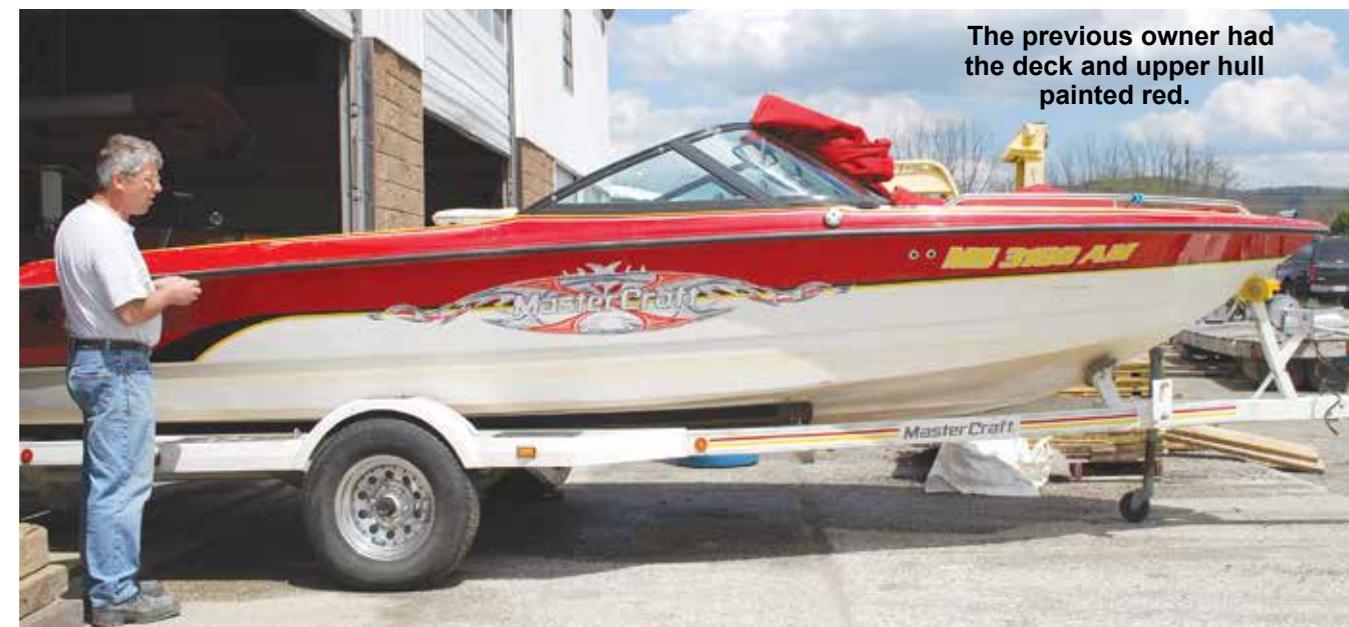
The previous owner had the deck and upper hull painted red to match the other tow boats on the team. Underneath all the red paint was the original color of the gelcoat; Oyster white, black, teal and grey.

The previous owner had the deck and upper hull painted red.

Peel Away was again used to strip off the red paint. Under the paint were many deep gashes and scratches especially on the starboard side. Areas along the forward keel had quite a lot of damage as well. All were repaired and the hull sanded. The owner decided he wanted to do two color gelcoats on the hull rather than the original four colors. Black and Oyster white were chosen. I followed the original design line of the former multiple colors under the rub rail and applied black gel. Below that I applied Oyster white gel. Both gels were sanded and compounded. New graphics were applied next and a new 1" silver stripe tape was added where the black and white gels met. The transition line came out so perfect we could have left off the stripe but the silver was a nice accent on the white and black. It also set off the new chrome "Mastercraft" decals. The hull was sealer glazed and then waxed.

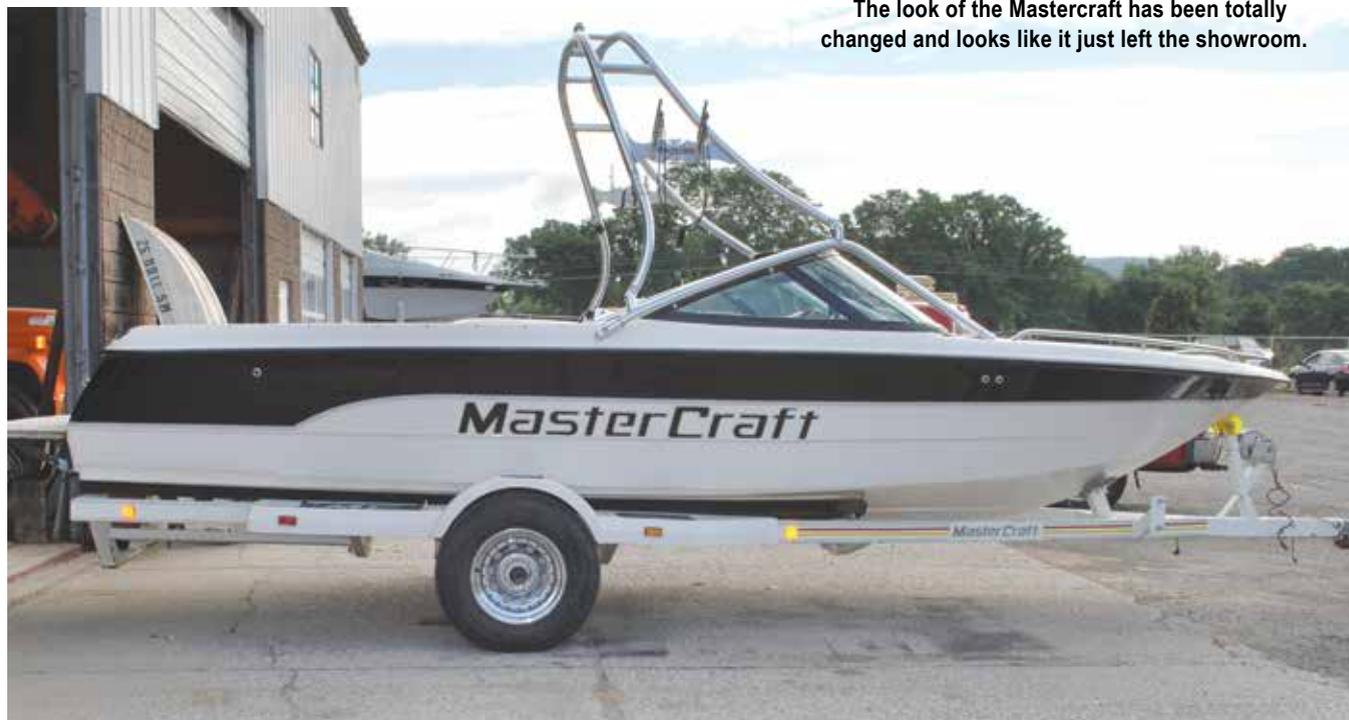
The look of the Mastercraft has been totally changed and looks like it just left the showroom.
