Ask Dr. Gel

Gelcoat Repair Training gives student added benefit!

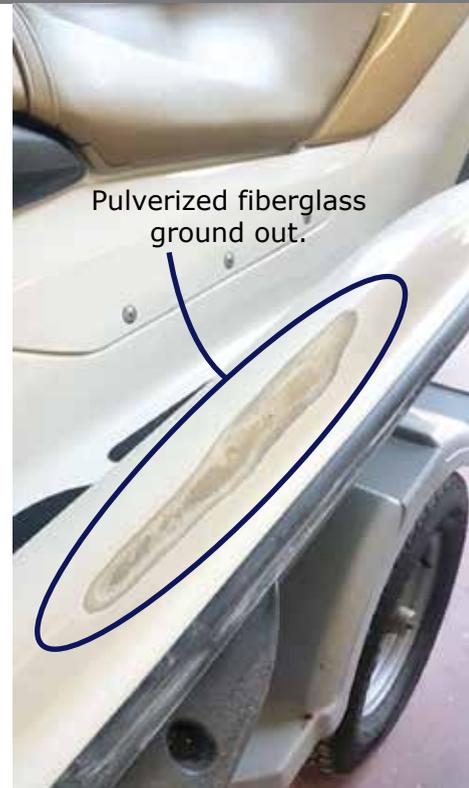
Pulverized fiberglass ground out.

The night before Eric came to the class he called and asked if he could bring the two damaged jet skis and do a repair in the class. He said one had a crack. We began the repair by grinding out all the fractured gelcoat and fiberglass until we revealed solid fiberglass. It was pulverized and had to be ground out almost all the way through the laminate. The fiberglass shattered on impact. Good fiberglass is deep purple in color, shattered is grey or white.

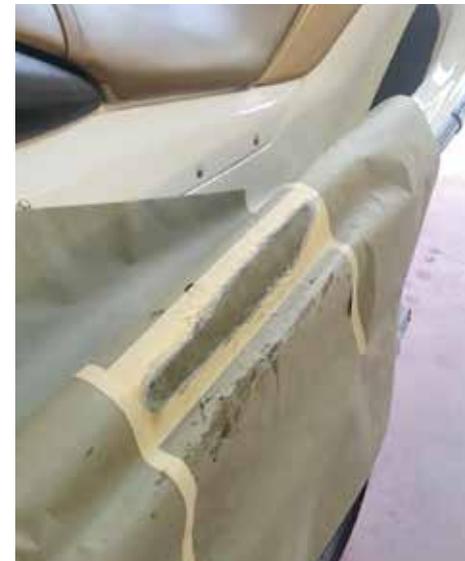
Lay up with fiberglass biaxle mat, Fiberglass cloth and resin.

The next step done was to rebuild the ground out area. We applied multiple layers of fiberglass biaxle mat, fiberglass cloth strategically cut and resin until we had a tolerance of less than 1/8 below the gelcoat surface surrounding the repair area. We then applied reinforced fiberglass fillers to straighten out any imperfections. We then sanded the area to re-establish the original body lines. The area was prepped for gelcoat. The custom matched gelcoat was applied, left to cure with a spray coat of PVA on it. It was then sanded with various grits of wet sand paper, compounded and finished with wax.

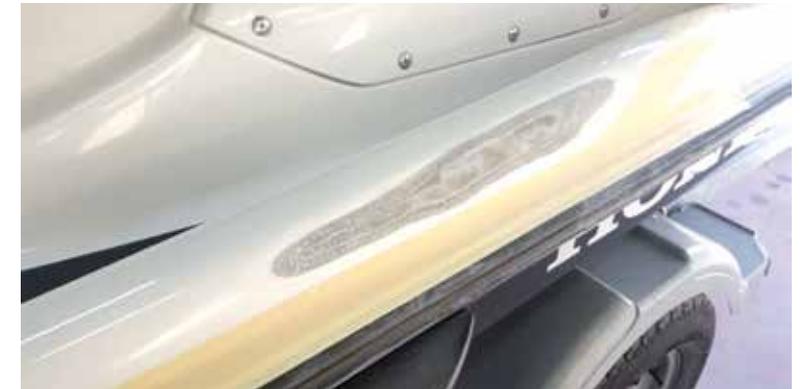
Lay up ground out, sanded and original body lines restored.

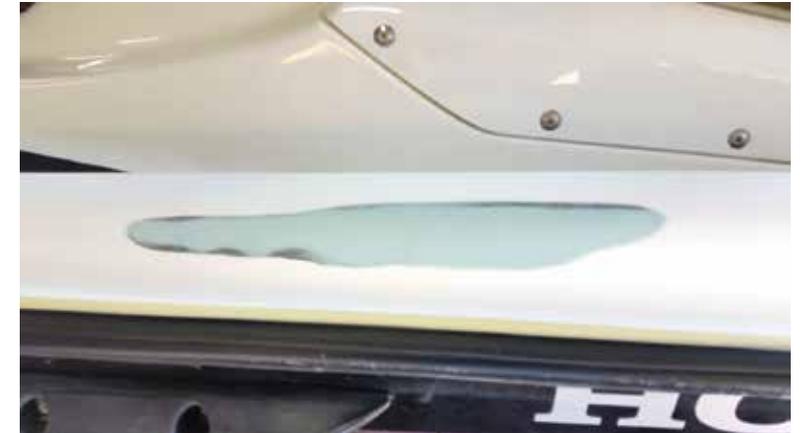
Thin layer of vinyl ester filler applied - ready for Gelcoat.

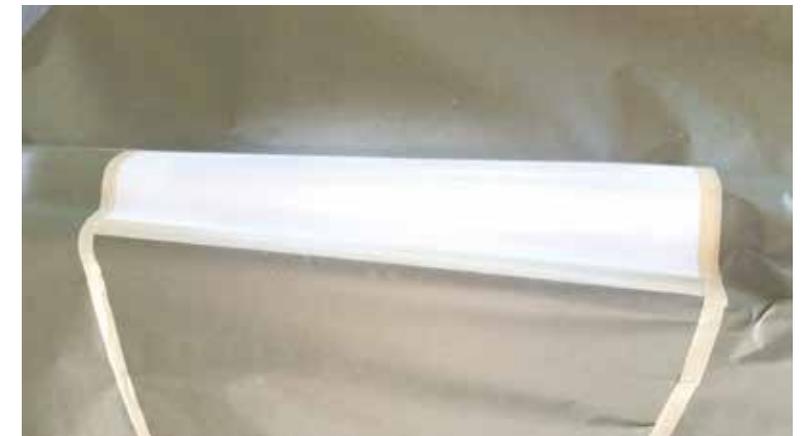
Gelcoat applied.

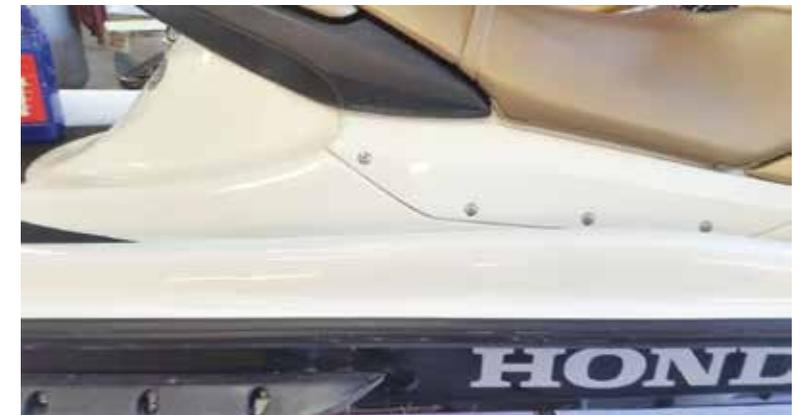
Finished repair - perfect custom color matched!

Although it turned out to be a bigger repair than what we normally do in a training class it was a great learning experience for Eric. We had to grind, lay up, sand, and color match. There was no time to order factory gelcoat so we custom tinted some of our stock white. It was a perfect match. Eric was ecstatic, confident and anxious to do additional repairs needed on both jet skis. We were able to cover most of the class training in this one repair.
