# Ask Dr. Gel

## “On The Rocks” ... not the kind I had in mind.

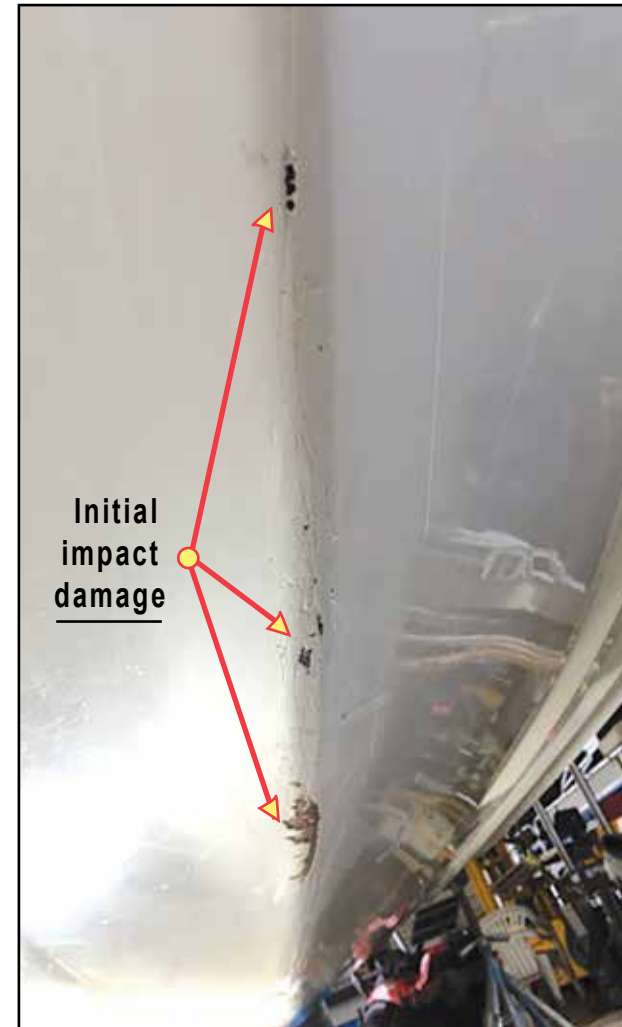
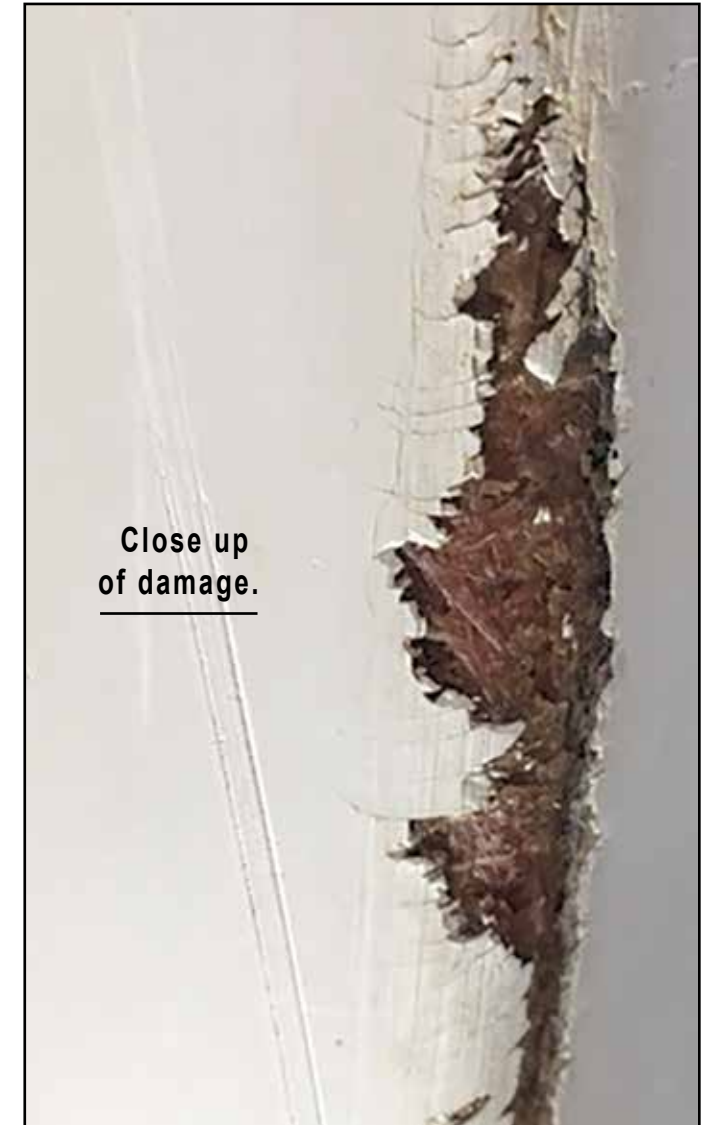
I could tell as soon as I saw it there were problems. Two areas had multiple cracks and they were dripping water. It remained on the trailer for another week at my shop and continued to drip water during that time. I got the OK from the owner to grind into it to see the extent of the damage. What I discovered was a laminate separation and water had migrated up in between the layers of the laminate. The damage was more serious than the boat owner thought. More problems were

created by leaving it in the water. In addition, as I inspected the hull further I discovered that the laminate separations were manufacturing issues. Delaminating caused by poor manufacturing and I have written articles about it. I have seen this occur in other boats during my many years of experience repairing boats. This manufacturing defect is adding more troubles for this owner!

It had a real crappy lay up! It looked like at the techs at the manufacturing plant sprayed the fiberglass chop mixed with resin and waited too long to add subsequent layup layers. Did they decide to go to lunch... The last layer they sprayed in acquired a blush and the subsequent layer added “after lunch” didn’t adhere. As a result no adhesion but they kept laying up the hull.

a breach. It was inevitable the hull was subject to extensive delaminating. This means strips of fiberglass would come loose from the bottom of the boat.

I ground out the damage, and laid it up properly with multiple layers of epoxy resin and mat, ground and sanded it. When that step was completed I prepped and applied epoxy barrier to finish. The layup on this boat was done poorly. It became known due to

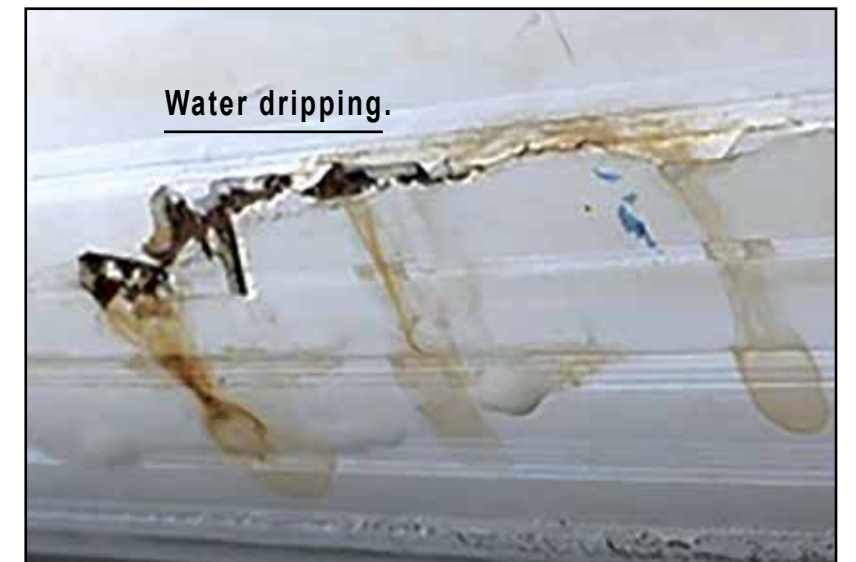
Darker area is seeping water out of laminate - Note droplet lower left.
