What's in Your Transom?

If you have mushrooms growing on your carpet you may have a problem!

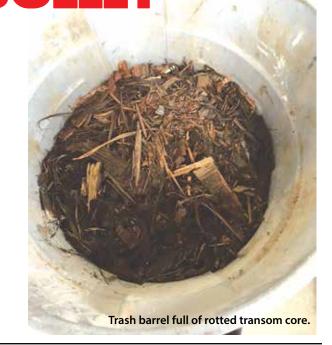
${f A}$ customer called from Downstate NY and wanted to get back into boating after twenty-five years. He previously owned a 23' Sea Ray back then. Now he was looking to buy a 25' and found a 1989 Sea Ray on Craigslist at a good price. It needed work which he proceeded to do. He put it in the water and found out it leaked and needed a new transom. After doing so much work on it already he felt he had to go ahead and have a new transom done. He asked how much and I told him what others had run but I needed to see the boat to do an estimate. So he drove 3 hours and brought the boat in. We did the estimate, the work was Ok'd and we proceeded to install the new transom. A new transom can run

anywhere between \$1500. - \$7000. plus, depending on the type of boat fiberglass or aluminum, size of boat, single or twin engine, how rotted it is, how much access there is to the transom, etc.

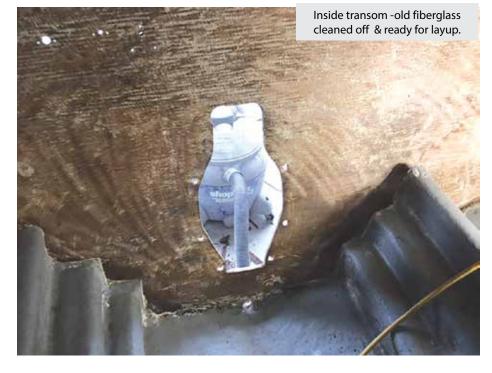
A transom can have different stages of deterioration. Most of the time all can be repaired.

Usually it's soaked up flotation staying wet that starts to rot the floor and stringers. From here the wetness works its way back to the transom. There can be good floors and stringers and a rotted transom. Each case is unique.

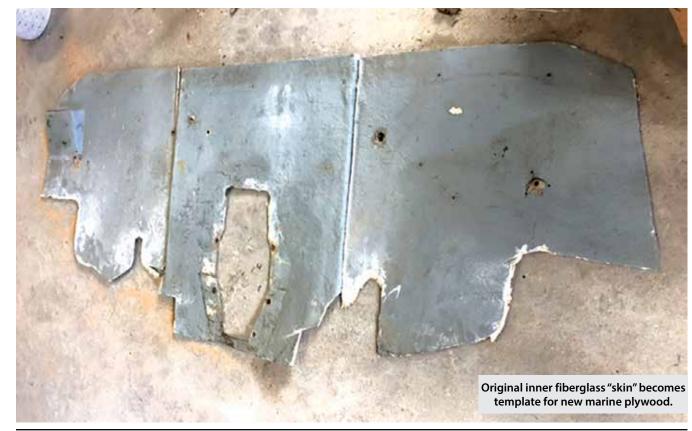
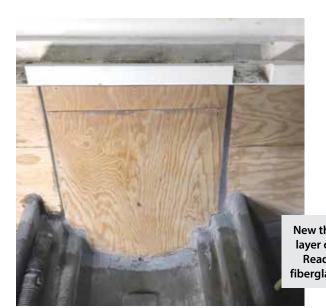
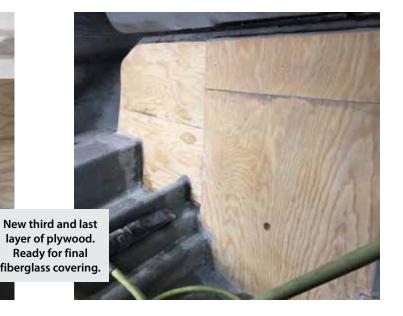
The first thing I do when there are transom decay concerns I look across the outside and inside of the transom and look for indentations where anything is thru bolted. When the transom was new it was really solid and bolts were tightened. In a soft transom the bolts have indented themselves into the transom. Next I use the handle end of a screw driver and do the ole' tap test on the entire transom. I am looking for a nice crisp solid ring tone indicating solidness. If there is a thud sound it means moisture and softness is present.

I continued to examine other parts of the boat. I check stringers and engine mounts. First I check to see if the engine mount bolts are tight. If they spin, it's likely there is moisture and softness present. The screw driver tap test can be done along the stringers also. Stringers can be built out of many different materials e.g. wood/foam/composite. The tap test will give an idea of what the condition of the stringer is but the best indicator would be to use a moisture meter.

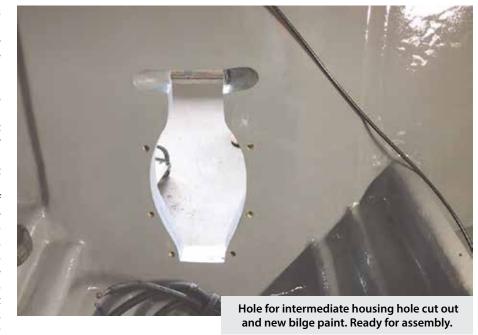
The bilge was cleaned, scrubbed, and degreased. Every bit of oil removed. Inside the transom the fiberglass "skin" was strategically, carefully and surgically removed using special equipment. This cut out "skin" was used to make a

cardboard template. The rotted core material was removed using chisels, pry bars, flat bars, hammer, vacuum, electric chain saw. I used whatever tool it took to clean out the water soaked core material.

Next I ground out the area and sanded it flat. I used the cardboard template to cut sheets of ¾" and ½" marine plywood. These were laminated together using vinyl ester resin and fiberglass cloth. I had to achieve a thickness of 2-1/4" for the new transom. This piece was inserted and secured. All the original holes including the large hole for the outdrive were recut. The entire project was painted with bilge paint to finish.
